Timber Repair Review

ISSUE 1

Review of Timber Repair & Preservation Techniques

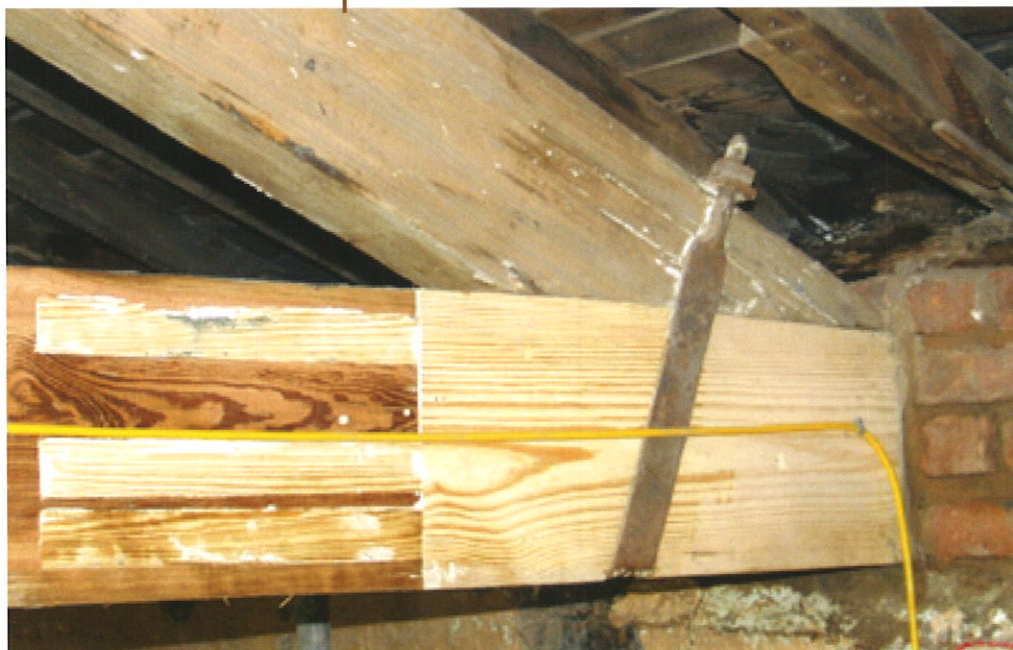
An example of Tie Beam Repair using a Timber Resin Splice, Macintosh Mill. © George Hockey 2007

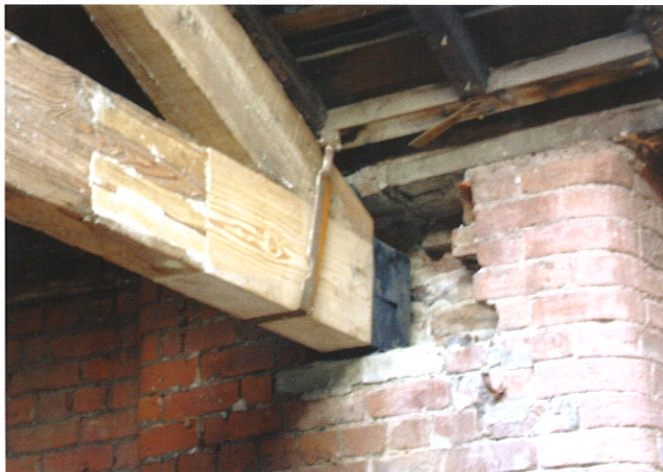
Timber-Resin splice in place

George Hockey, Managing Director of Trace Remedial Building Services, has been instrumental in surveying the extensive rot problems in the bearing ends of the Mill's carrier beams, tie beams and rafters and chose to specify the Timber-Resin Splice technique. Over 35 of these repair end units were manufactured in matching Pitch Pine and fitted on site by Trace Remedial's technicians.

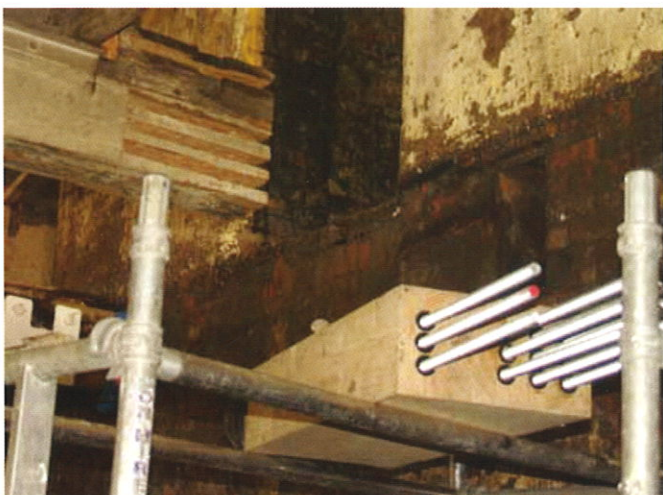
Slots cut, ready to fit Timber Resin Splice

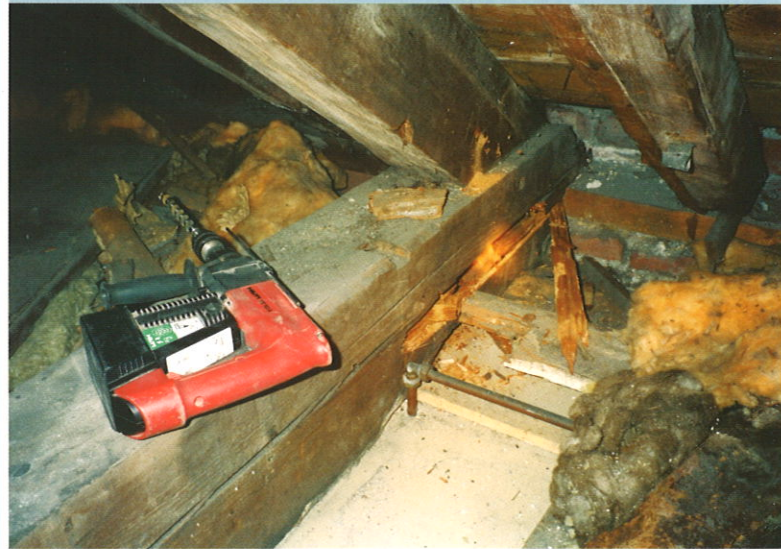
An example of rot in a Tie Beam Bearing End

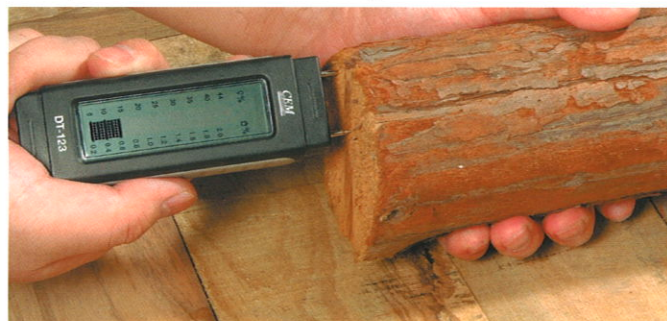
Measuring dampness in Timber

The remaining timber will be damp – conductivity meter testing should be used to see how far along the timber readings above 18% can be found. This will determine the treatment zone. Timber below 18% is not vulnerable, but care must be taken to allow for the possibility of seasonal re-wetting – for example, in mid Summer an exposed timber frame may be down to 10% moisture content, but we can safely predict that it will become vulnerable to decay during the next Winter.

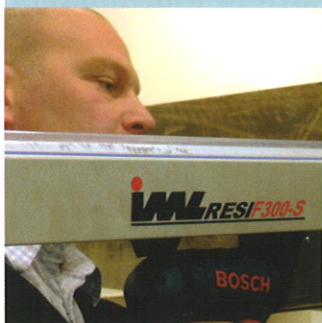
Resistograph drilling in progress

The Resistograph machine is basically a high speed electric drill attached to a very fine stainless

By charting the results we can accurately show where decay has occurred. This gives a Surveyor or Contractor enough information to decide a cut off point and to specify dimensions for a timber repair, for example the Timber-Resin Splice system.

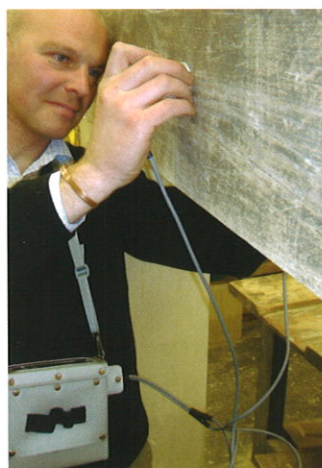
Ultrasound in use

Yes, used in exactly the same way, Ultrasound does indeed give us an instant reading of the density of timber and this enables us to locate areas of reduced density, most likely to be caused by decay.

This preliminary test takes little time and is invaluable because it allows us to focus our main test, the Resistograph, on small areas, saving time and money.

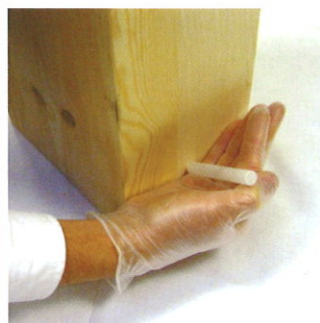
Installing a Boron rod

Borate based preservatives provide the best long term protection against rots and insect attack because they remain inside the timber long term – they have no vapour, do not evaporate and love moisture, thus spreading themselves readily through the damp, most vulnerable areas.
